PASSAIC RIVER BASIN
ROCKAWAY RIVER TRIB.
MORRIS COUNTY,
NEW JERSEY

SWANNANOA LAKE

NJ 00311

**PHASE 1 INSPECTION REPORT
NATIONAL DAM SAFETY PROGRAM**

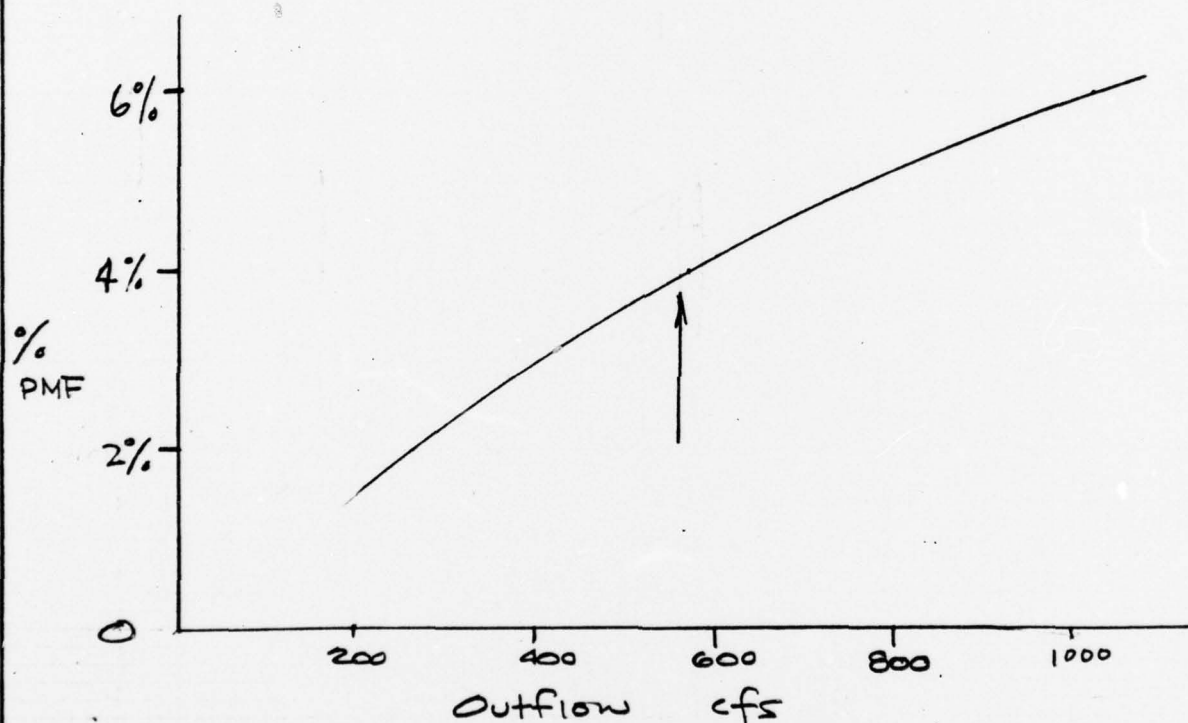
OVERTOPPING POTENTIAL

3. Dam overtops at approx el 773 with $Q = 560$ cfs
 \therefore dam can pass approx 3.9% the PMF
